# YOUR INSPECTION REPORT

3206 Brook View Drive  
Any Town, MN

Sunday, December 18, 2011

RE: Report No. 1003  
3206 Brook View Drive  
Any Town, MN

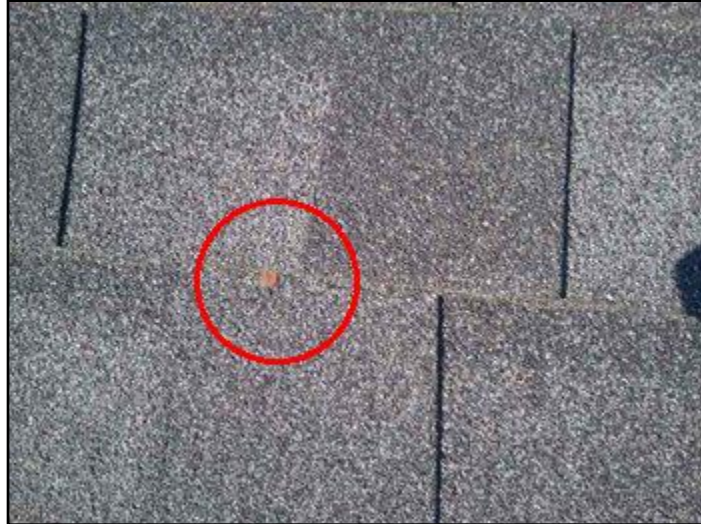
*exposed fastener / granule loss*

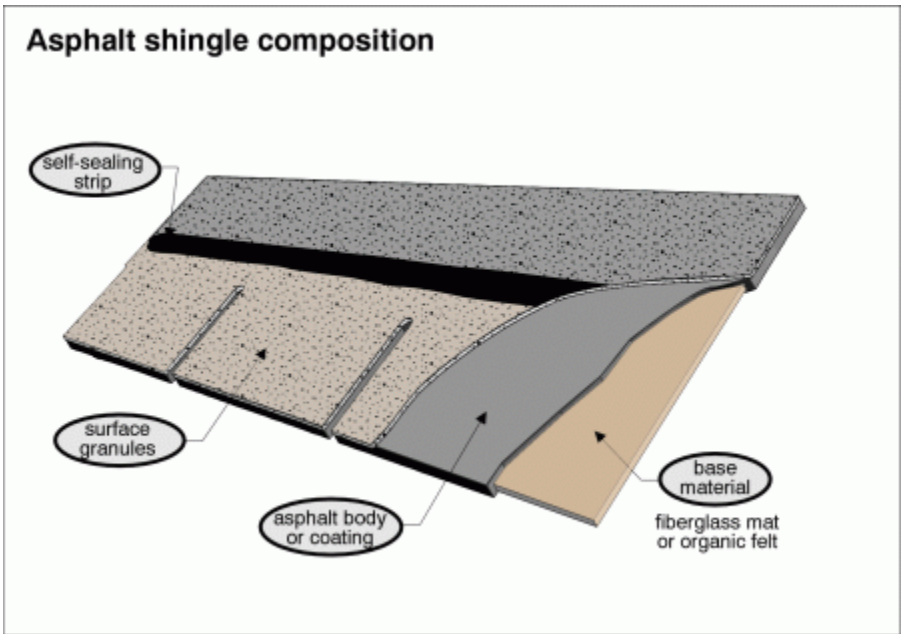
**Condition:** • Granule loss

**Implication(s):** Chance of water damage to contents, finishes and/or structure

**Location:** Throughout

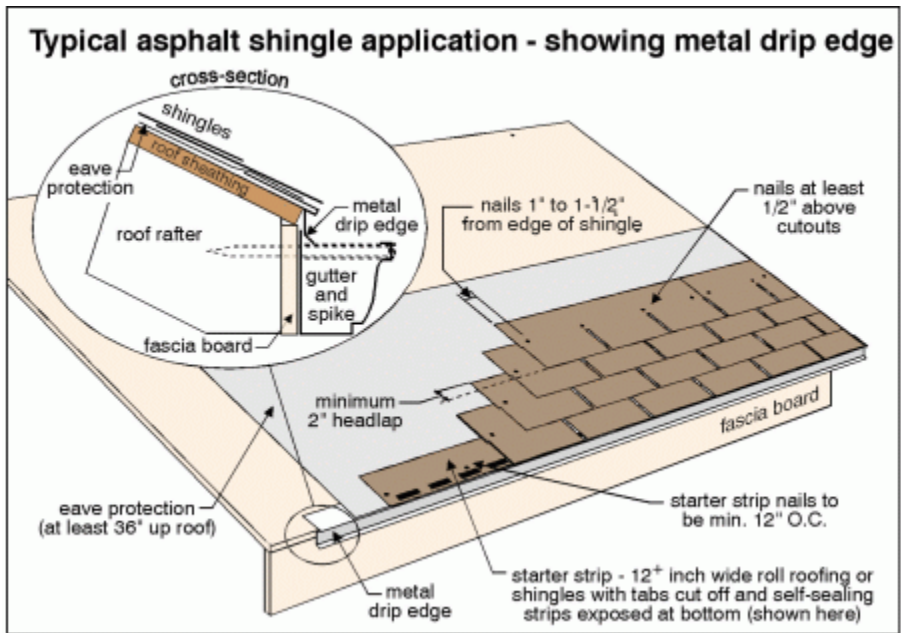
**Condition:** • Exposed fasteners

**Implication(s):** Chance of water damage to contents, finishes and/or structure

**Location:** West

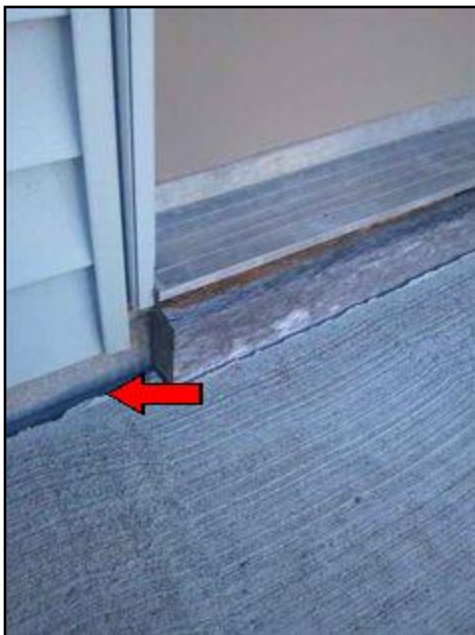
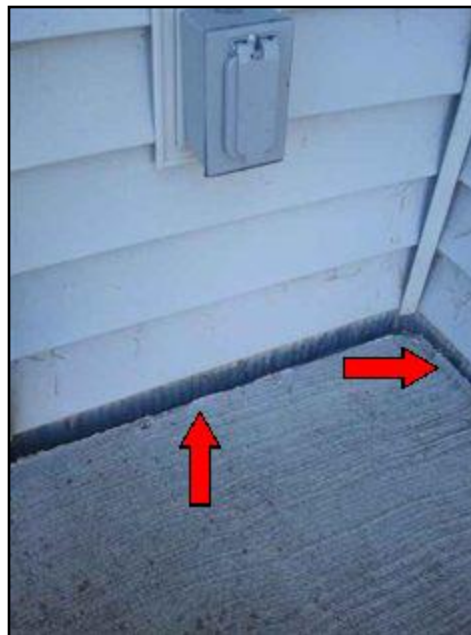
concrete separating from foundation

*Concrete separated from foundation rear patio*

**Condition:** • Unsealed gap at house

**Implication(s):** Chance of water entering house

**Task:** Repair

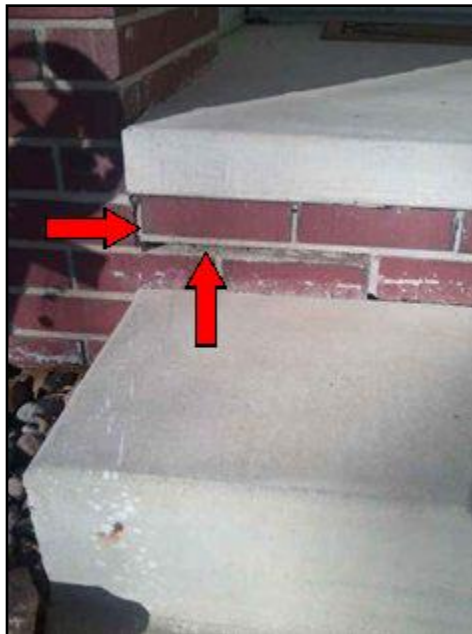
bricks separated under concrete slab. settling has occurred.

*Bricks separated*

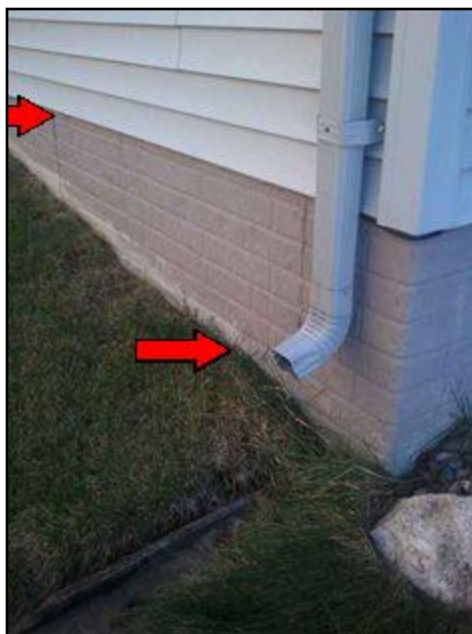
**Condition:** • Downspouts end too close to building

**Implication(s):** Chance of water damage to contents, finishes and/or structure

*Discharge should be 6' min.*

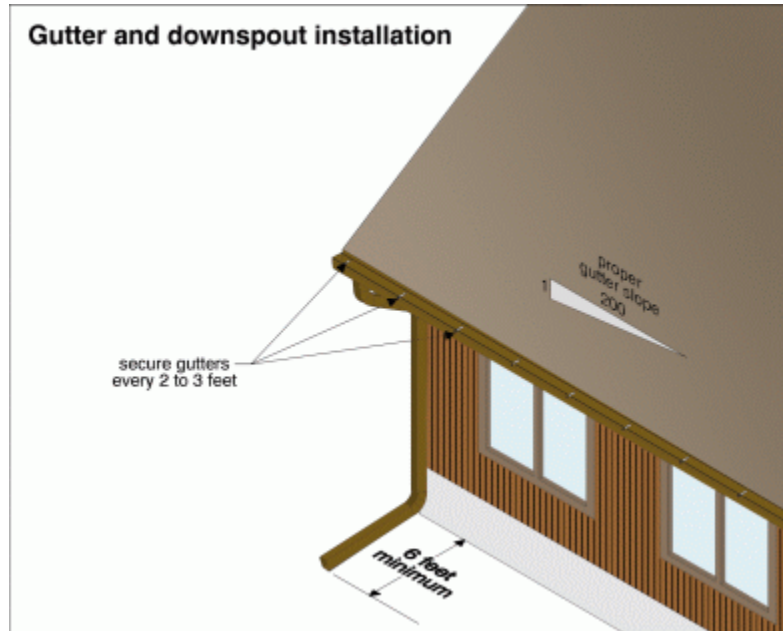
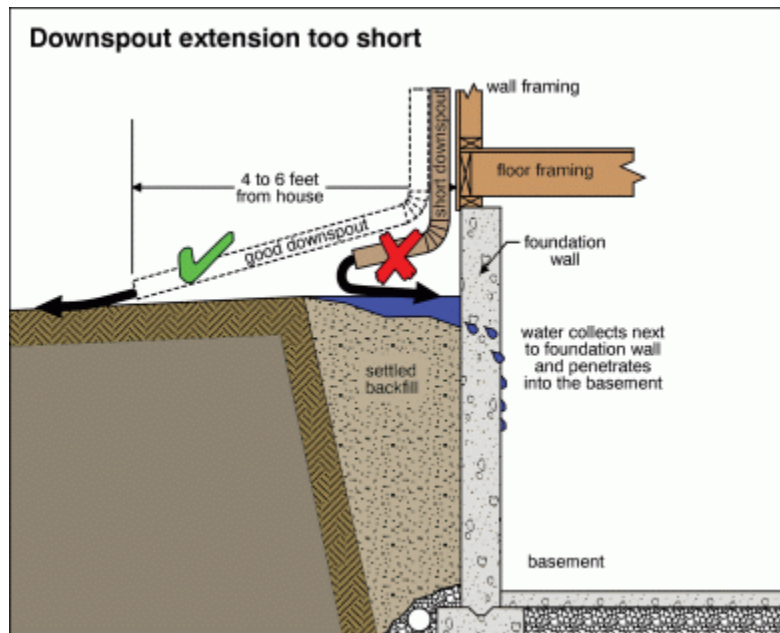
**Condition:** • Should discharge 6ft. from home

**Implication(s):** Chance of water damage to contents, finishes and/or structure

**Location:** Throughout

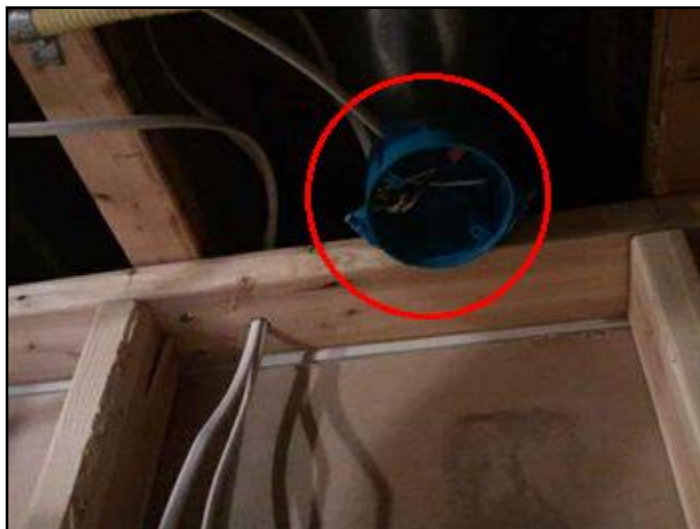
**Condition:** • Cover loose or missing

**Implication(s):** Electric shock | Fire hazard

**Location:** Basement Furnace Room

missing cover

**Task:** Correct

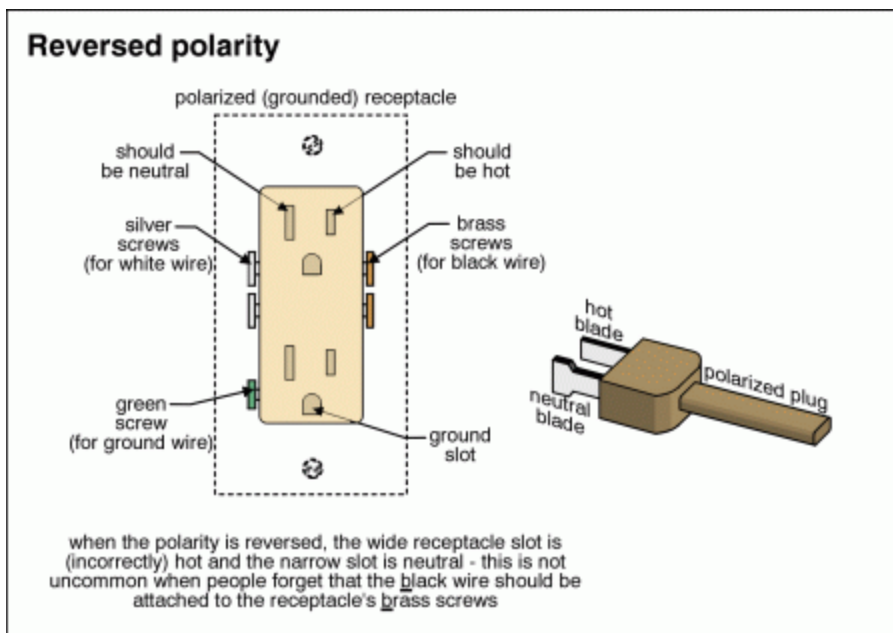
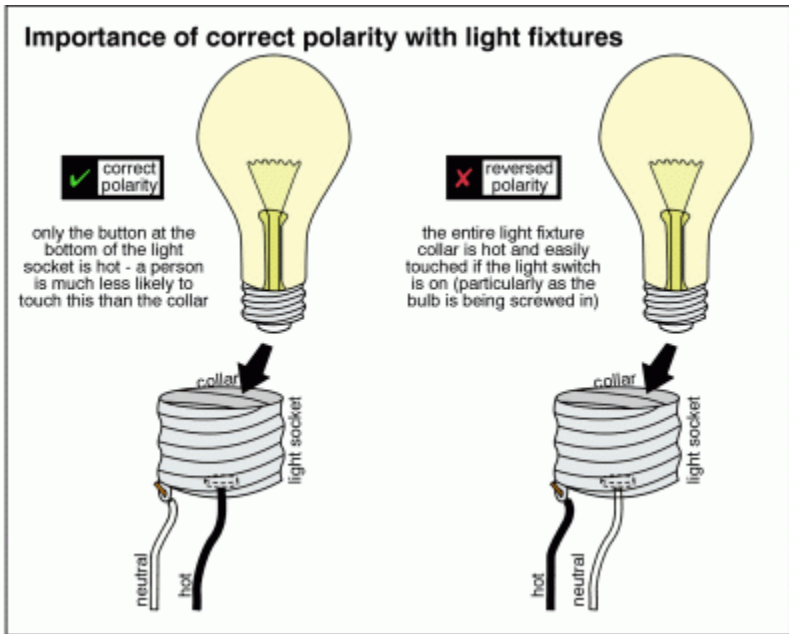
**Condition:** • Reversed polarity

**Implication(s):** Electric shock

**Location:** Basement Bedroom

**Task:** Correct

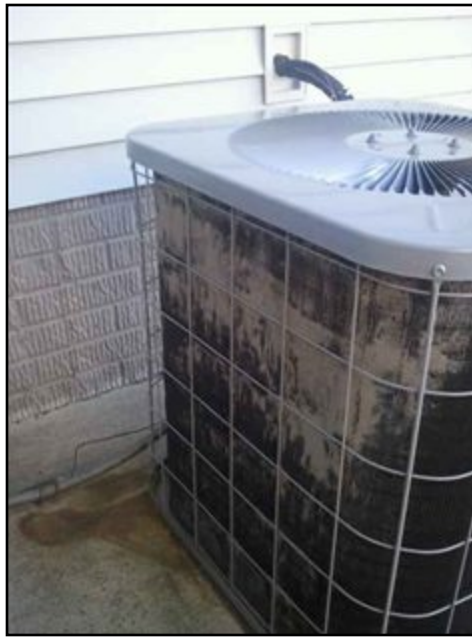
*needs cleaning*

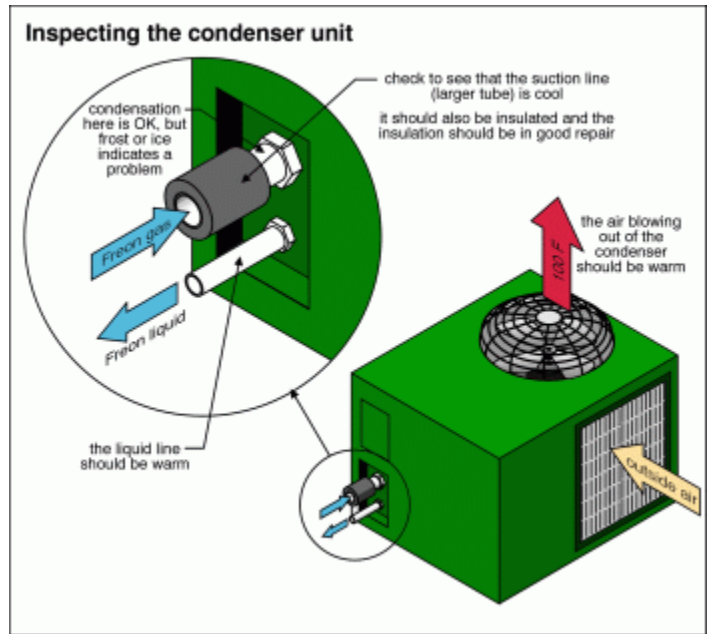
**Condition:** • Dirty

**Implication(s):** Reduced system life expectancy | Increased cooling costs | Reduced comfort

**Task:** Clean

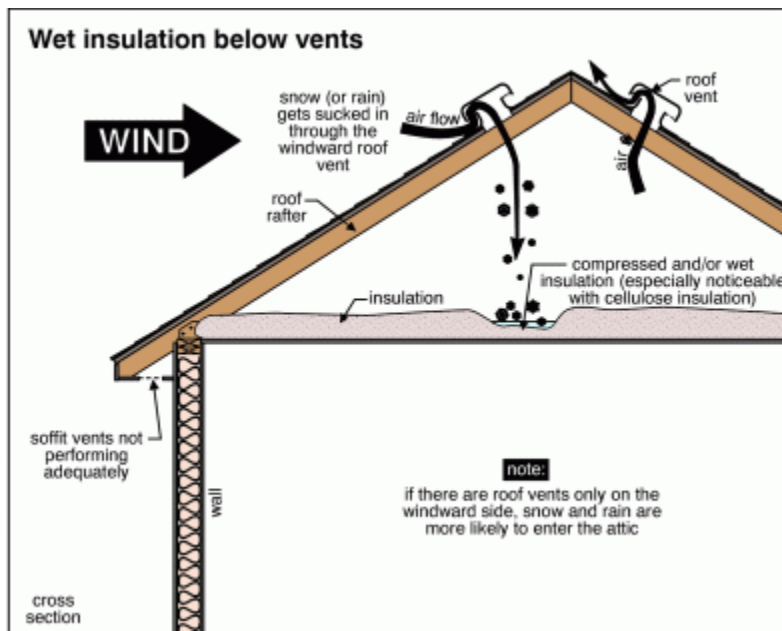
**Condition:** • Snow or wet spots below roof vents

**Implication(s):** Chance of water damage to contents, finishes and/or structure | Chance of condensation damage to finishes and/or structure

**Task:** Further evaluation

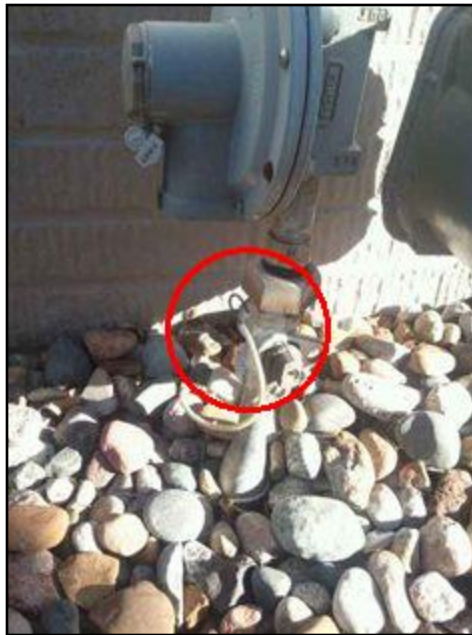
**Condition:** • Improper connections

*Improper connections*

**Task:** Correct

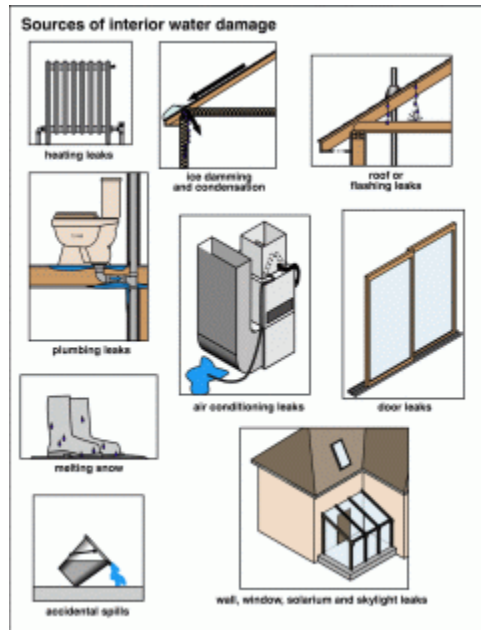
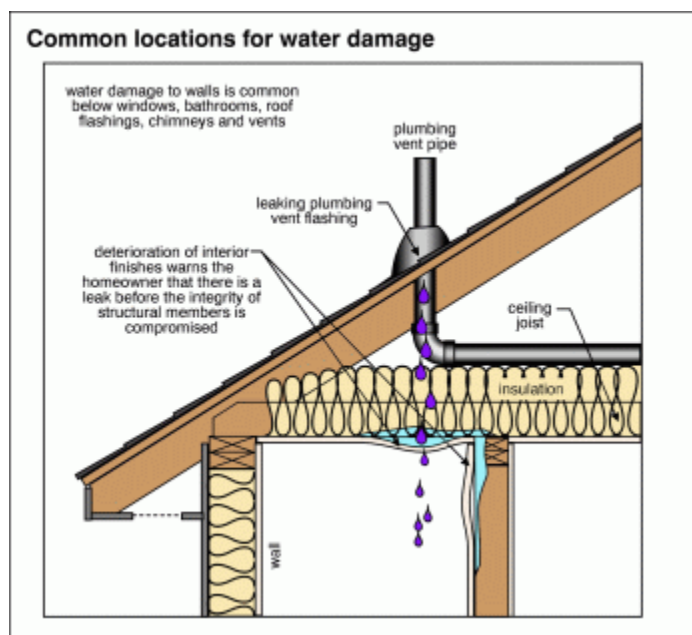
**Condition:** • Water damage

**Implication(s):** Cosmetic defects | Chance of movement

recommend replacement of fans to remove moisture.

**Task:** Replace fan
